The following report is provided as an amendment to the Bean Creek Westslope Cutthroat Trout Restoration Plan prepared by Confluence dated January 1, 2006. The site conditions and infrastructure have changed since the original plan was prepared. Confluence conducted a site visit and performed additional survey on August 15, 2013 to evaluate the current conditions and update the restoration plan accordingly.

The project is approximately 10 miles west of Lakeview in the Centennial Valley of southwestern Montana (Figure 1). The project lies entirely on private lands just north of public lands administered by the BLM.

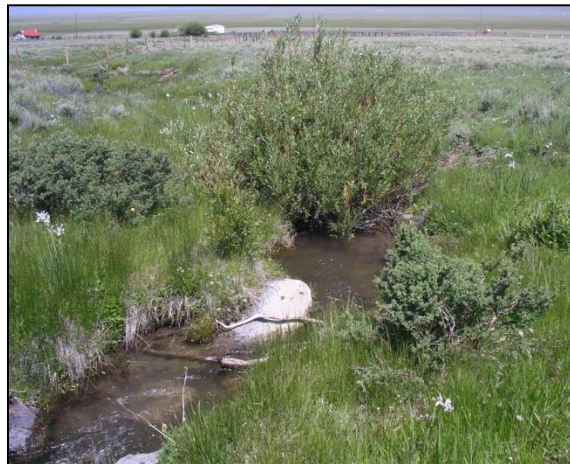
Immediately upstream of the project site Bean Creek exists in a relatively pristine condition (Figure 2). In this reference reach the stream is a low width to depth ratio B3 channel (Rosgen 1996) with large cobble substrate. It is characterized as being moderately entrenched with irregular scour pools formed around a coarse cobble substrate. This channel type typically forms on coarse alluvial fans such as the one present where Bean Creek exits the Centennial Mountains. Riparian vegetation is abundant in the form of both woody (willow) species and herbaceous wetland species (rushes and sedges) immediately adjacent to the channel.

Figure 2. Reference reach.

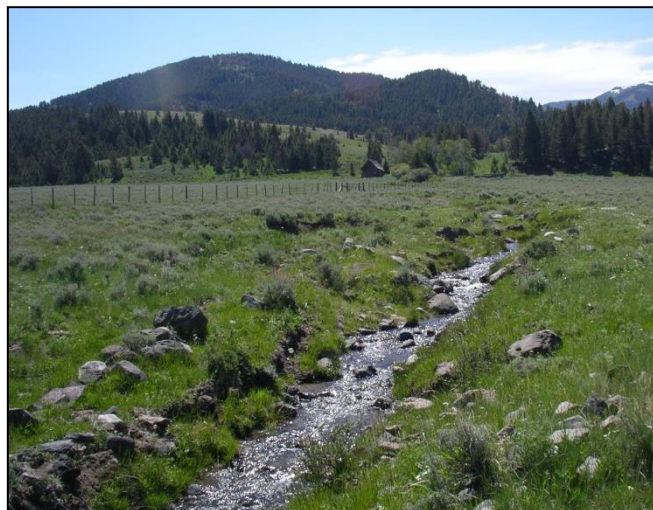
South of the County Road, Bean Creek has been significantly impacted by anthropogenic factors including channel straightening, overgrazing, and removal of woody riparian vegetation (Figure 3). This section offers little habitat for resident trout and is uninhabitable in the winter due to ice formation. These impacts have resulted in a steep, over wide, shallow channel that lacks both deep water habitat and overhead cover. In the winter months the existing conditions promote the formation of frazil and anchor ice. By December, the creek commonly becomes jammed with ice and frozen solid to the stream bed. With no deep water habitat trout are unable to survive the winter in this reach.

Figure 3. Channelized Reach of Bean Creek. Note large cobble removed from the channel.

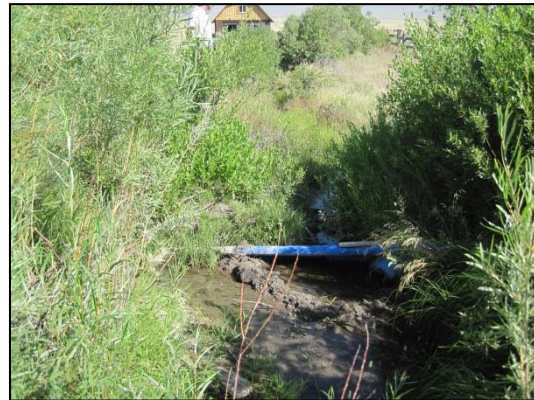
Downstream of the channelized reach, Bean Creek flows through private lands currently utilized for agricultural operations. The creek flows diagonally across the county road via a 36" corrugated metal culvert. An irrigation diversion, currently controlled by tarps, is located immediately downstream of the road. Downstream of the diversion, Bean Creek's flows are split between a natural channel and a pond. The pond has a degraded 12" gate inlet structure, also due to frost heaving causing water to flow underneath the structure.

Figure 5. Irrigation Diversion with tarp.

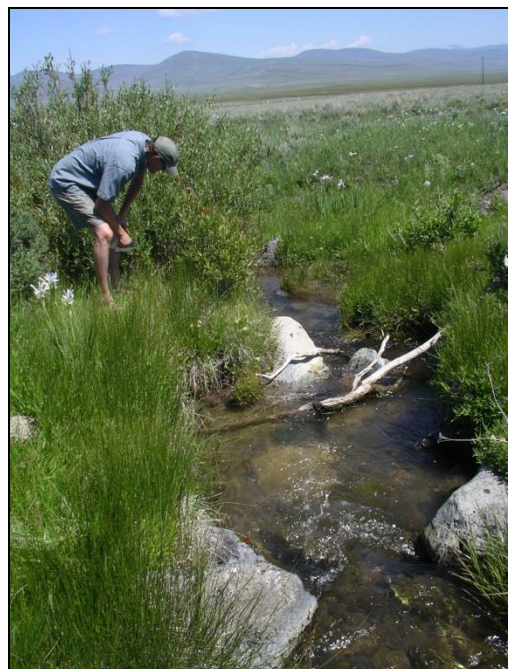
A reference reach approach determined appropriate and sustainable pool types and dimensions for the discharge and channel characteristics of Bean Creek. Typical of B3 channels on coarse alluvial fans, the majority of the pools in the reference reach are rock scour, backwater, and step pools (Figure 9) spaced every 3 to 5 bankfull channel widths (Wbf ~ 6 feet). Bankfull pool depths range from 1.25 to 2 feet. Large rocks are common in this reach of Bean Creek and are the main formative feature associated with pools. When Bean Creek was channelized, these large rocks were removed and the channel widened. The proposed restoration aims to utilize the available rock to construct pool supporting structures. Rock placement will be determined based on observation of existing habitat forming features in the reference reach. Pools will be constructed every 3 to 5 channel widths resulting in approximately 30 new pools.

Figure 9. Reference Reach Pool Habitat
